4. TITLE (and Subtitle) MULTIPLE-PURPOSE PROJECT KANSAS RIVER BASIN REPUBLICAN RIVER MILFORD LAKE OPERATION AND MAINTENANCE MANUAL APPENDIX IV CONSTRUCTION FOUNDATION REPORT		5. TYPE OF REPORT & PERIOD COVERED Construction Foundation Report From June 1962 to Dec 1966

APPENDIX IV
CONSTRUCTION FOUNDATION REPORT

1977
(Revised October 1983)

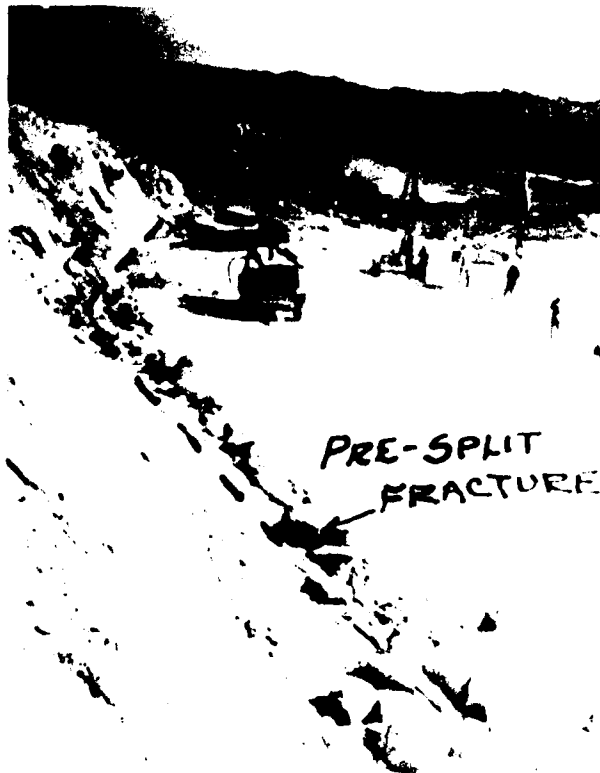
4. Milford Dam,
October 1962,
Neg. No.
294-P4-4.
Pre-split
fracture with
primary
drilling in
progress.

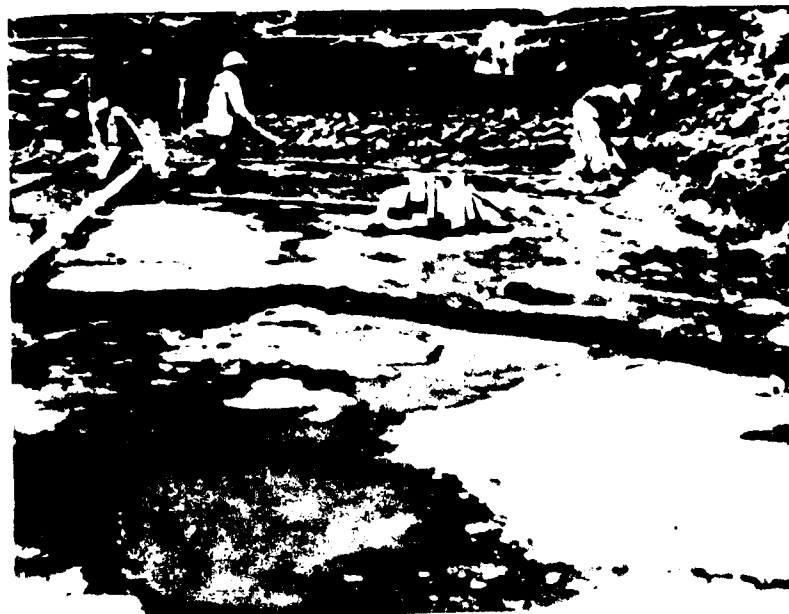
22. Milford Dam, November 1962, Neg. No. 294-P1-2.
Stilling basin foundation from station 4+73D to
station 4+93D, Schroyer limestone.

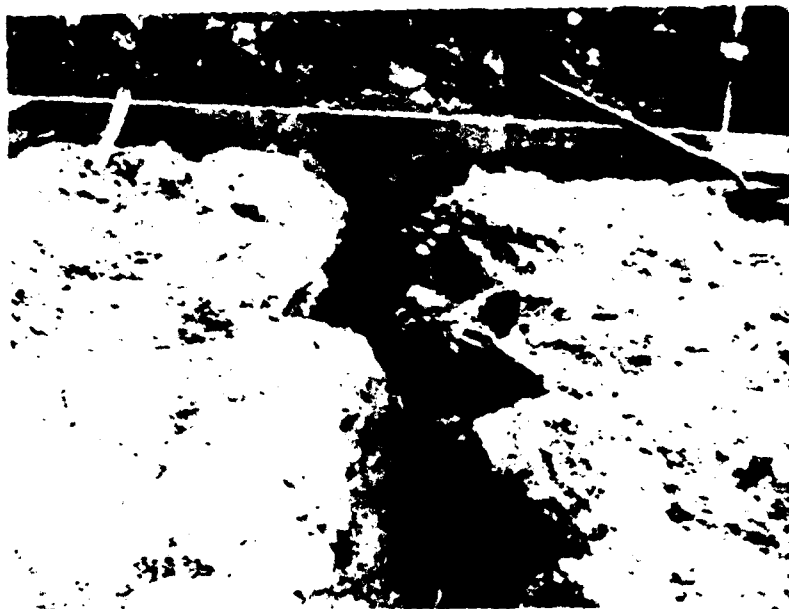
25. Milford Dam, November 1962, Neg. No. 294-P2-11.
Joint in approach slab foundation after clean-up,
Blue Springs shale zone "A".

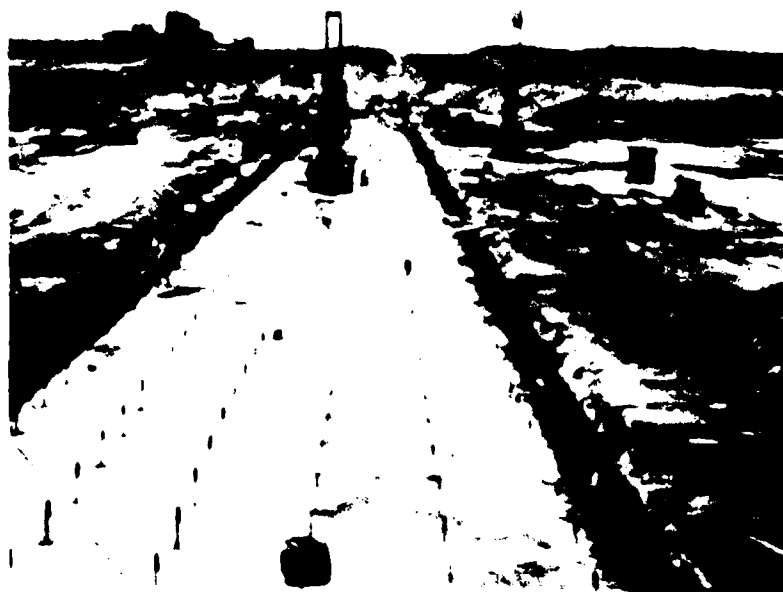
34. Milford Dam, May 1963, Neg. No. 294-P2-6.
Work in progress in sill area. Grouted anchors are set through lean slab in foreground while rotary drills anchor holes in background.
